Quarterly Progress Report #1

(May - July, 2003)

**Land Application of Residuals and Chicken Manure
in the Lake Okeechobee Watershed:
Phosphorus Considerations**

**UNIVERSITY OF
FLORIDA**

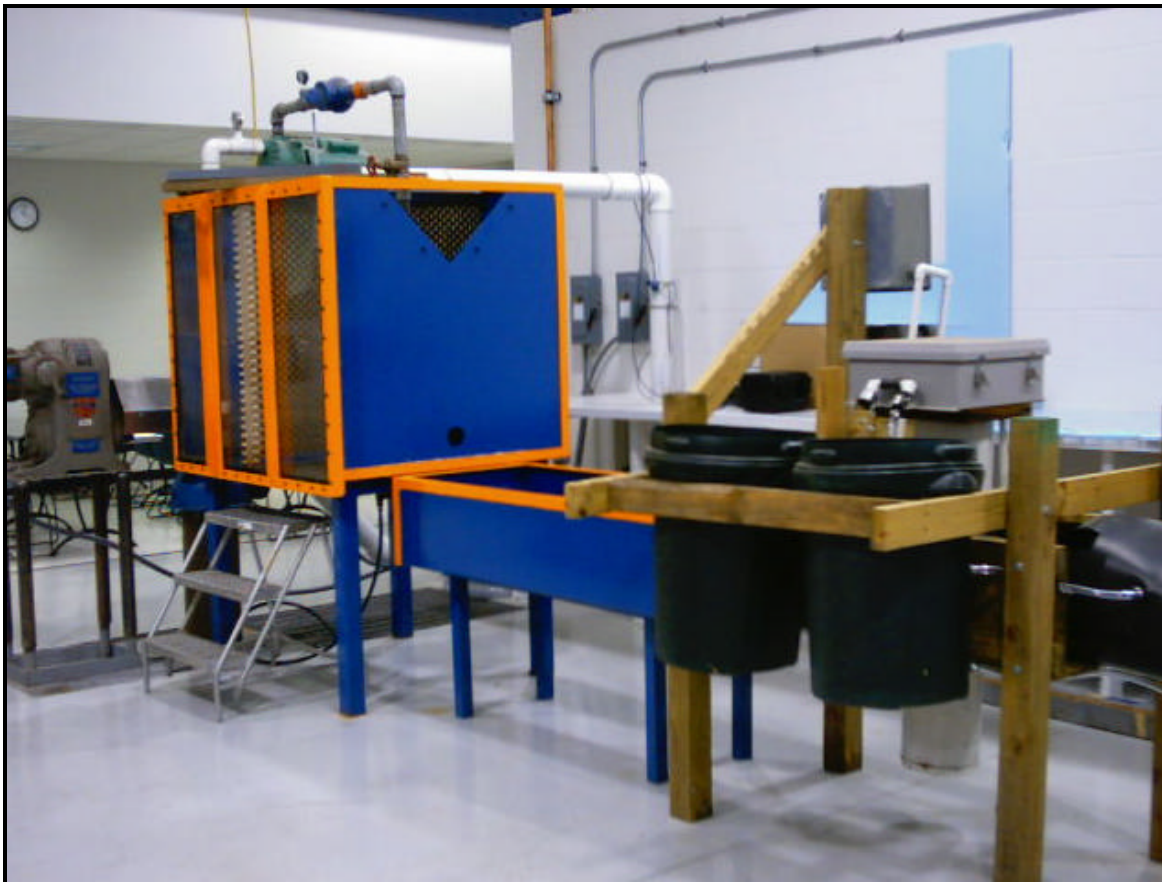
Figure A14. Testing of surface water sampling system at University of Florida.

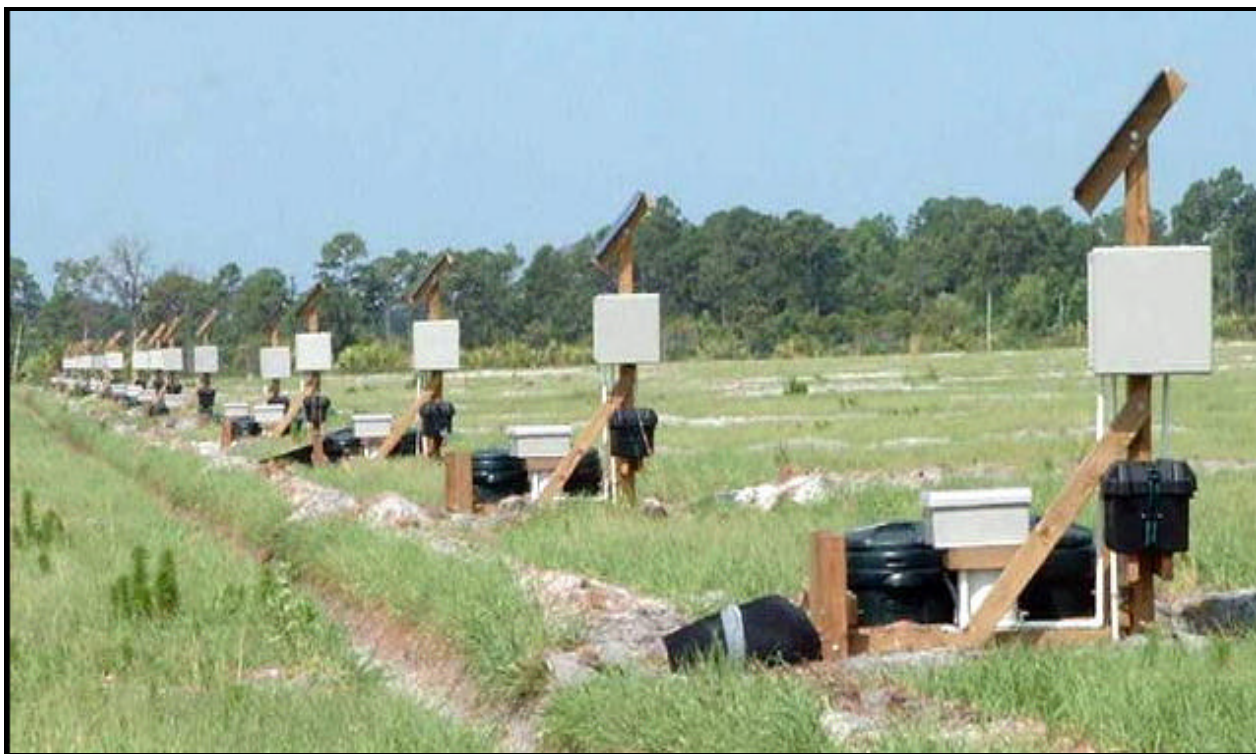
Figure A15. One of the three rows of surface water samplers installed at Kirton Ranch.
